Back Relief

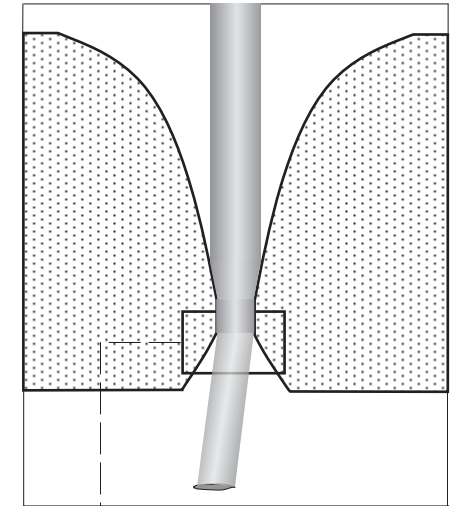
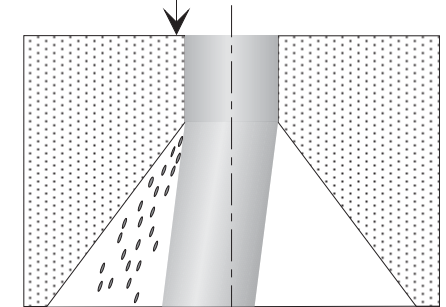
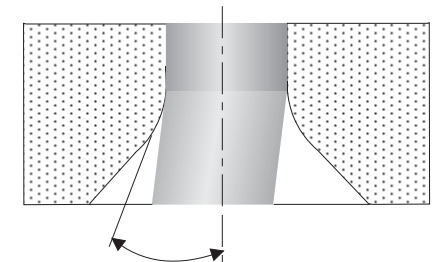
On wire drawing machines, dies are not tightly secured, and therefore are not perfectly aligned.

If the end of the bearing has a sharp edge, the wire could be shaved. This means that small metal particulates could be torn off the wire which in turn can:

The friction against the sharp edge on the bearing's exit can also create vibrations for the wire which spread within the machine.

To avoid this sharp edge, the exit angle between the cylindrical bearing and the exit of the die needs to be rounded off and smooth.

This **Back Relief** is more so critical with increased wire drawing performance (speed, multi-lines, etc..)
